Manhole Inspection Summary

Manhole # S51A__019MH

Insp Date: **5/5/08 11:09 AM**

Location Address: **201 n curley**

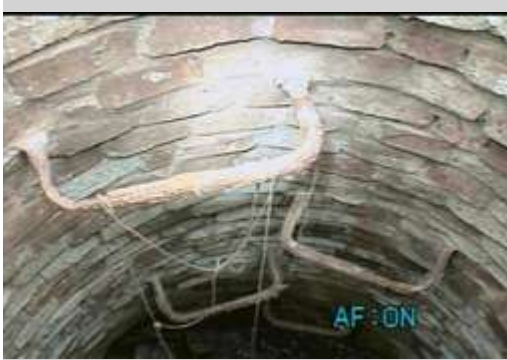
Defect 2

Count: **4** Missing: **0** ☒ **Corroded**

steps

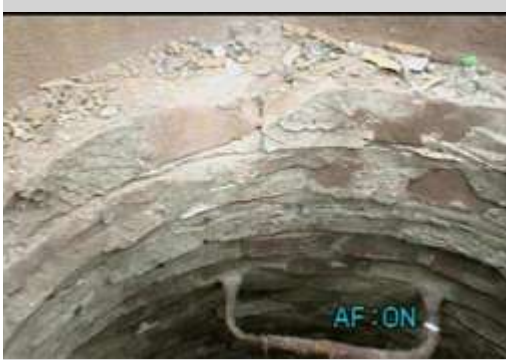
Defect 1

Offset: **2** (in.)

offset

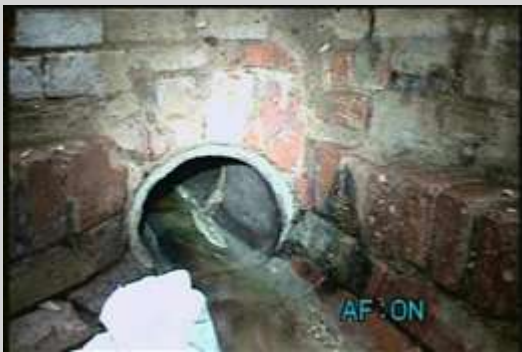
12 O'Clock Outflow

8 in. Circular Gravity Sewer
Pipe Out @ 12 O'Clock

Pipe Material: **Clay** ☐ Pipe Lined

Invert Depth: **8.44** (ft.) Flow Characteristics: **Fast**

Deposits: ☒ None ☐ Mud ☐ Sludge ☐ Debris ☐ Grease

Infiltration: **None** Pipe Seal Cond: **Unknown**

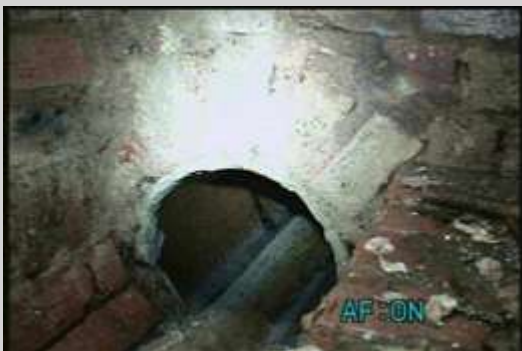
6 O'Clock Inflow

8 in. Circular Gravity Sewer
Pipe In @ 6 O'Clock

Pipe Material: **Clay** ☐ Pipe Lined

Invert Depth: **8.38** (ft.) Flow Characteristics: **Fast**

Deposits: ☒ None ☐ Mud ☐ Sludge ☐ Debris ☐ Grease

Infiltration: **None** Pipe Seal Cond: **Unknown**

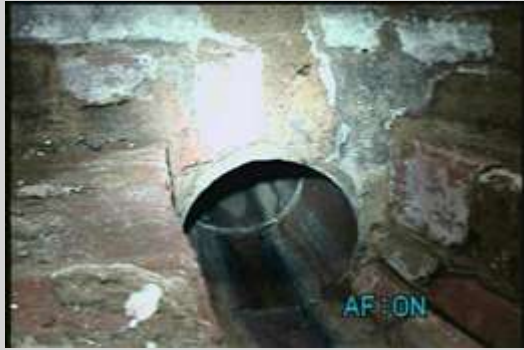
9 O'Clock Inflow

8 in. Circular Gravity Sewer
Pipe In @ 9 O'Clock

Pipe Material: **Clay** ☐ Pipe Lined

Invert Depth: **8.30** (ft.) Flow Characteristics: **Fast**

Deposits: ☒ None ☐ Mud ☐ Sludge ☐ Debris ☐ Grease

Infiltration: **None** Pipe Seal Cond: **Unknown**
